ARCHAEOLOGICAL RESOURCES ASSESSMENT AND HISTORIC RESOURCE REVIEW, TROUT BROOK RESERVOIR DAM REMOVAL PROJECT, BERKSHIRE, FRANKLIN COUNTY, VERMONT

UVM Report No. 1639

October 21, 2024 Revised February 26, 2025 REDACTED

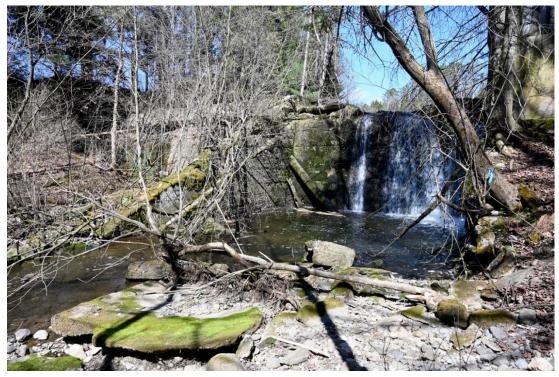
Figure 2. View of the downstream face of the Trout Brook Dam, looking north.

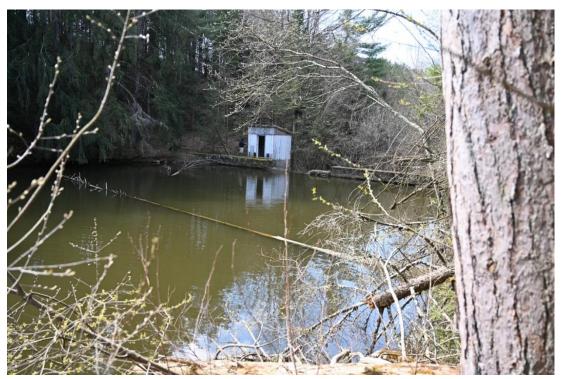
Figure 3. View of the upstream face of the Trout Brook Dam, looking southeast from the right bank of the impoundment.

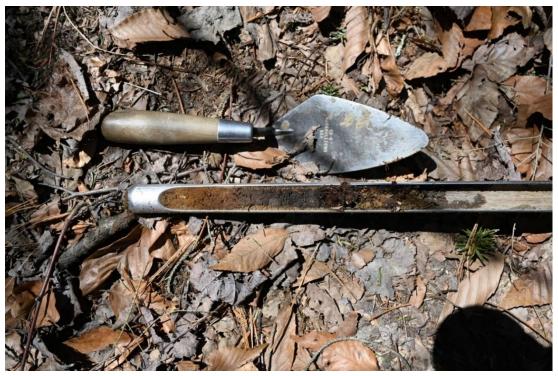
Figure 20. View of a hand core showing a largely undisturbed upper soil profile in the archaeologically sensitive area within the western access route on the right (west) side of the impoundment.

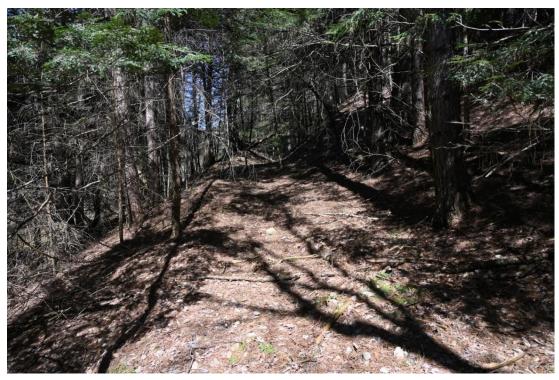
The proposed eastern access route follows an old road cut in 1924 when the dam was built. This road was created by extensive cut and fill into a moderate to steep side slope (Figures 21-23; see Figure 4). The area is not considered sensitive based on the steepness of the original slope and the historic period ground disturbance.

Figure 21. View along the proposed eastern access route to the project area, looking north; note cut and fill into steep slope.

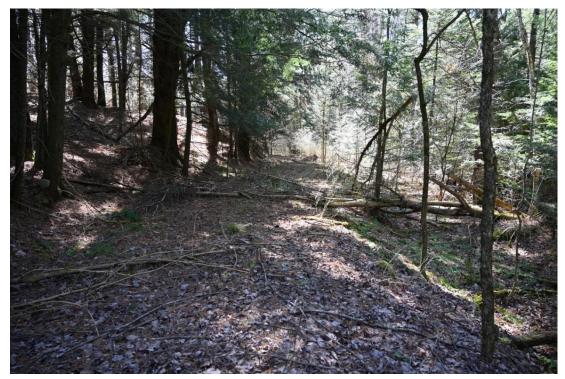
Figure 22. View along the proposed eastern access route, looking south; note cut and fill into steep slope.

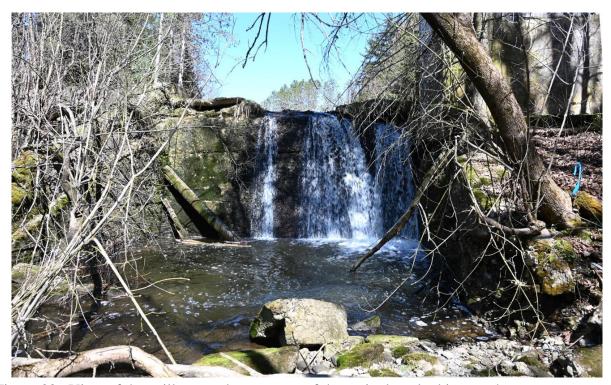
Figure 38. View of the spillway and apron area of the main dam, looking north.

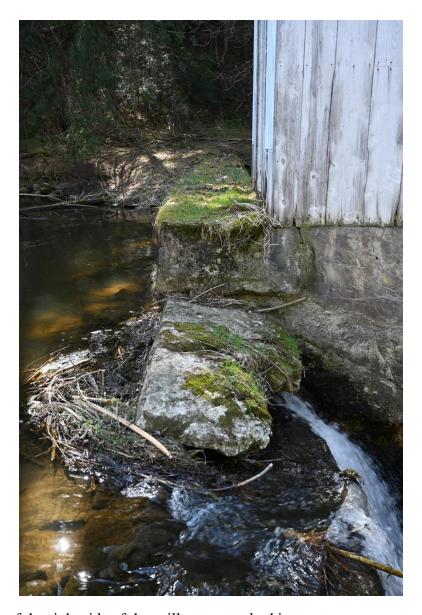
The spillway is located roughly in the center of the dam (Figure 41) (Enosburg Falls 1925:26). It was designed as "20 ft in width" and its crest was set at "2 ft below the top of the main dam" (Figure 42) (Enosburg Falls 1925:26). It appears that the spillway crest has been modified since its construction by the addition of some concrete, possibly to repair and/or reinforce this area, as it is now only 18 in deep. On either side of the spillway on the downstream

Figure 41. View of the right side of the spillway crest, looking east.

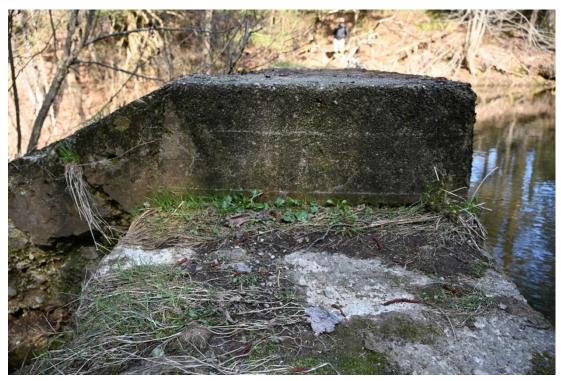
Figure 42. View of the right side of the spillway crest, looking west.

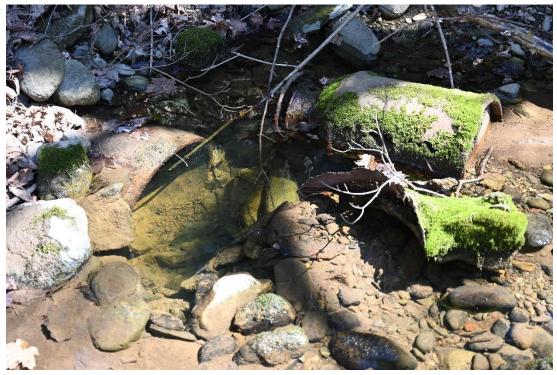
Thorpe noted that, "a blow-off pipe is provided and discharges into the brook at a point a short distance below the dam" (Enosburg Falls 1925:26). The end of an 18 in diameter iron pipe was observed partially buried in the streambed about 18.5 ft south of and about 5 ft below the visible concrete portion of the control chamber, which could be the 'blow-off pipe' (Figure 54; see Figure 52).

Figure 54. View of iron pipe / possible "blow-off pipe" south of the gate house and control chamber on the left side of the spillway.

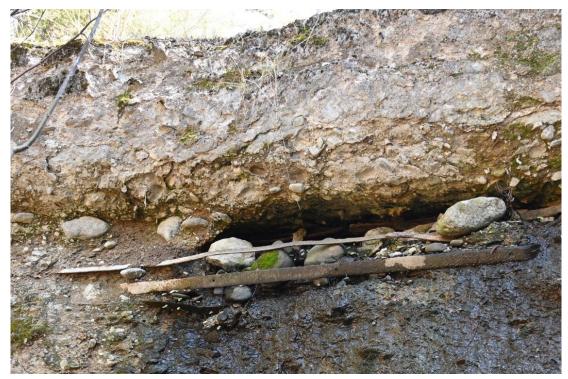
builders chose to use scrap metal. Initial research suggests that some low head concrete dams built from ca. 1904 up to the 1920s may contain scrap metal, such as old rails (especially light gauge rails), rods, iron wagon tires, iron pipes, collected from blacksmith shops, machine shops, manufacturing plants, etc., instead of the more standardized / engineered metal reinforcements (Brown 1905:346; Fegley 1915:5; Van Wegenen 1909:107). In this dam, all the metal reinforcement elements observed were different: different sizes, different shapes; some perforated, some not. The most common group appears to be very slightly curved, punched beveled bars with rounded ends ranging from 2 to 2.5 in wide (Figure 55) (SLR 2023). However, other pieces are very different (Figure 56). The method of reinforcement placement was the 'loose bar' or 'loose-rod system,' meaning that each piece of reinforcement was placed "as a separate unit without any mechanical union to its neighboring piece" (Ballinger and Perrot 1909:10). Though some of the pieces appeared to be lapped, they were not connected. The larger metal elements run horizontally through the structure, but between the lifts there appears to be a series of two strand twisted wires (together totaling about 1/8" in diameter) placed every 16 in / 1.33 ft (or so) running from heel to toe through the structure (SLR 2023). These are most likely wire form ties used to stabilize the wooden concrete forms used in the construction of the dam when filled with concrete.

Figure 55. View of exposed metal reinforcement elements on the left side downstream face of structure; also note the concrete aggregate sizes and volume.

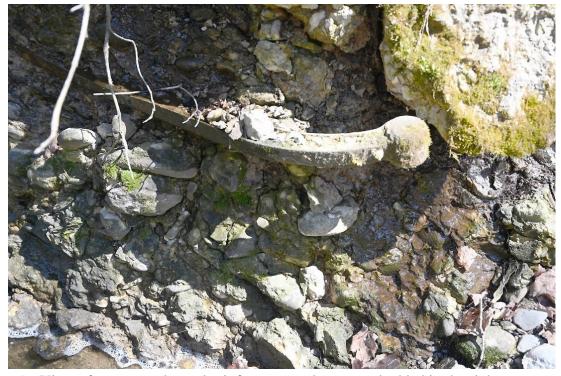
Figure 56. View of an exposed metal reinforcement element embedded in the right apron wall.

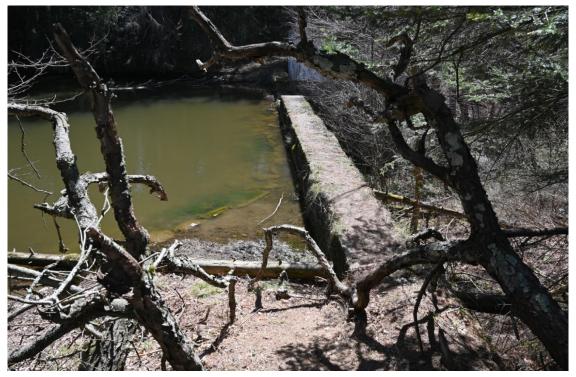
Figure 57. View of the upstream stone pavement feature, looking eastwards.

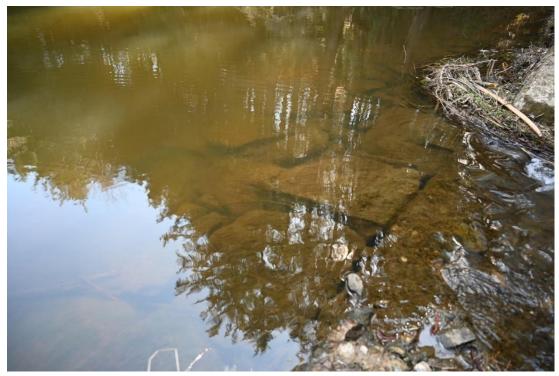
Figure 58. View of the pavement feature on the upstream side of the dam, looking northeast.
