Johnsons Mill Dam Removal Multi-Year Monitoring Sediment Transport Analysis Report

Johnsons Mill Sediment Transport Analysis Report

*Cover Photo:
Orthomosaic
imagery of the
Johnsons Mill Dam
Removal site
collected in August
2025, Year 4 of the
monitoring project.*

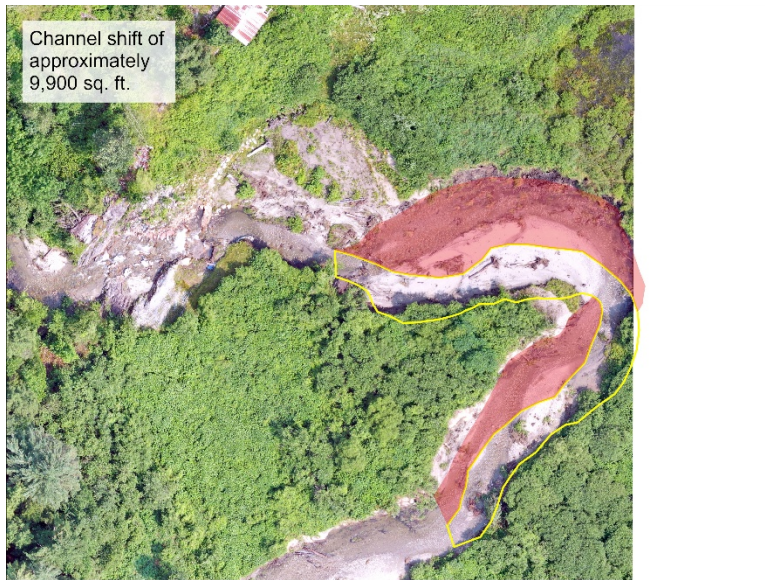
Figure 13. Areal channel adjustment in former dam impoundment captured by imagery collected before (June 2023, outlined in yellow) and six days after the July 2023 Flood (shaded in red).

Aerial imagery collected at a higher frequency than the topographic and bathymetric lidar data sets was used to evaluate the extent of areal channel adjustment associated with each flood event in 2023. This analysis was completed for the meander bend within the former dam impoundment. Following the July 2023 Flood, the channel adjusted by 9,900 sq ft (Figure 13). Following the December 2023 Flood, the channel adjusted by an additional 5,460 sq ft (Figure 14). In both cases, erosion occurred along the outer bank of the meander bend and deposition contributed to the growth of the point bar on the inside of the meander bend, and with overall meander bend migration in the downstream direction. Imagery collected in summer 2025 shows the establishment of vegetation on the developing point bar.
