Multi-Year Habitat Monitoring at Johnsons Mill Dam Removal – 2025 Annual Report

19-093

Multi-Year Habitat Monitoring at Johnsons Mill Dam Removal 2025 Annual Monitoring Report

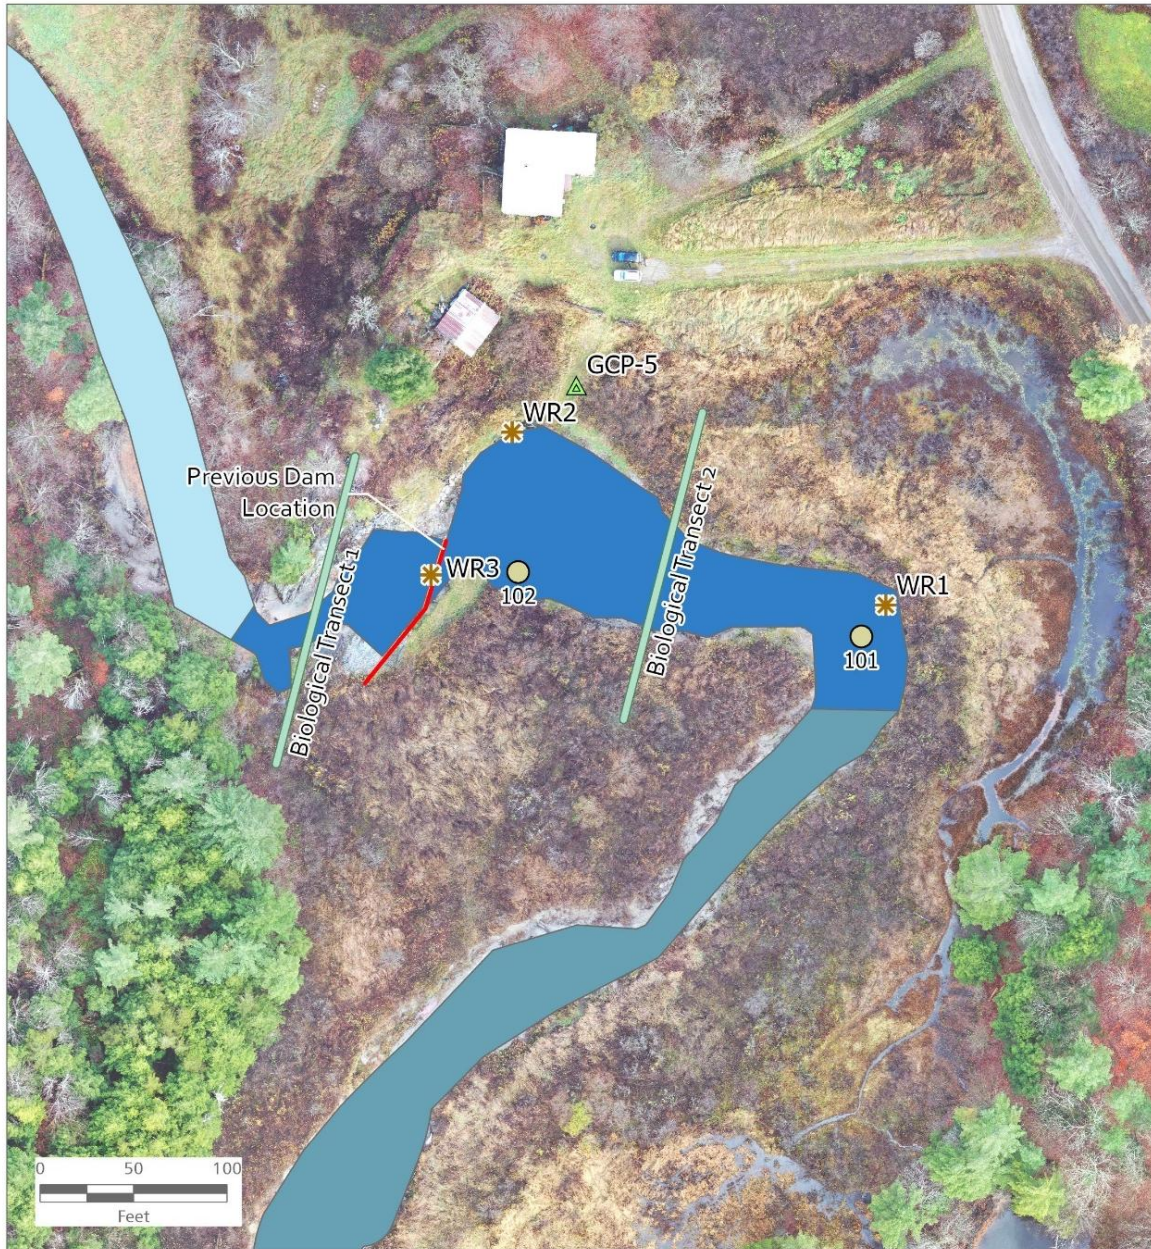
Figure 2. Wood recruitment, sediment sampling, and biological sampling locations established during Year One (2022) monitoring and revisited during subsequent monitoring events.

Sites 101 and 102 were identified for repeated streambed material analysis, representing different habitat types at the time of selection (see Figure 2 for locations). The same locations were assessed every year, though due to the changes experienced on the site, the habitat type did not remain the same throughout the monitoring period. At each location, Stone staff completed pebble counts using the Wolman pebble count method to determine grain size distributions. After pebble counts were completed, visual and tactile assessment methods were used to determine relative percentages of material beneath the surficial armor layer at one location toward the center of the channel at each streambed monitoring site. Each monitoring location was inspected for key roughness features and if present, dimensions and angularity were recorded. Photos were taken of each station. Data were processed in MS Excel to determine grain size distributions and approximate percentage of materials.

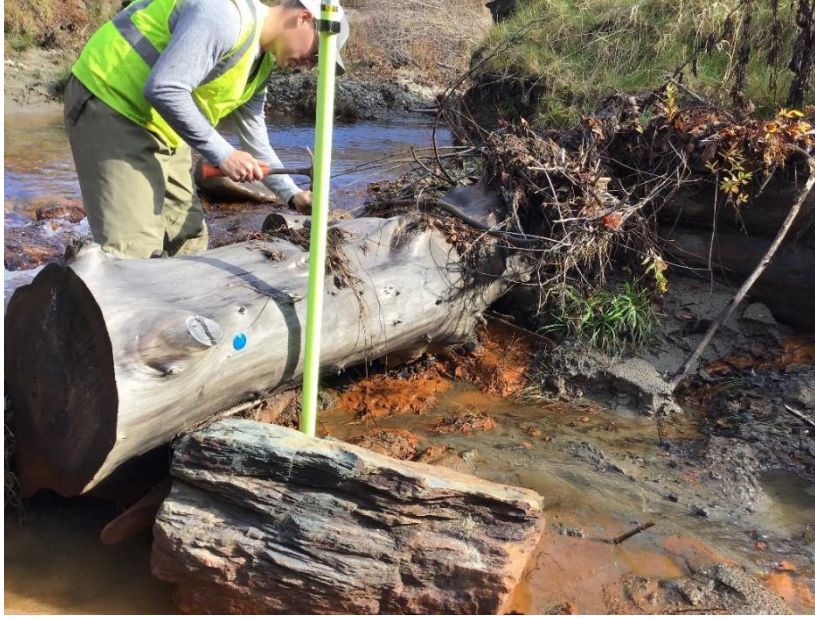
Figure 3. Stone staff tagging and collecting GPS locations of wood at monitoring station WR3.

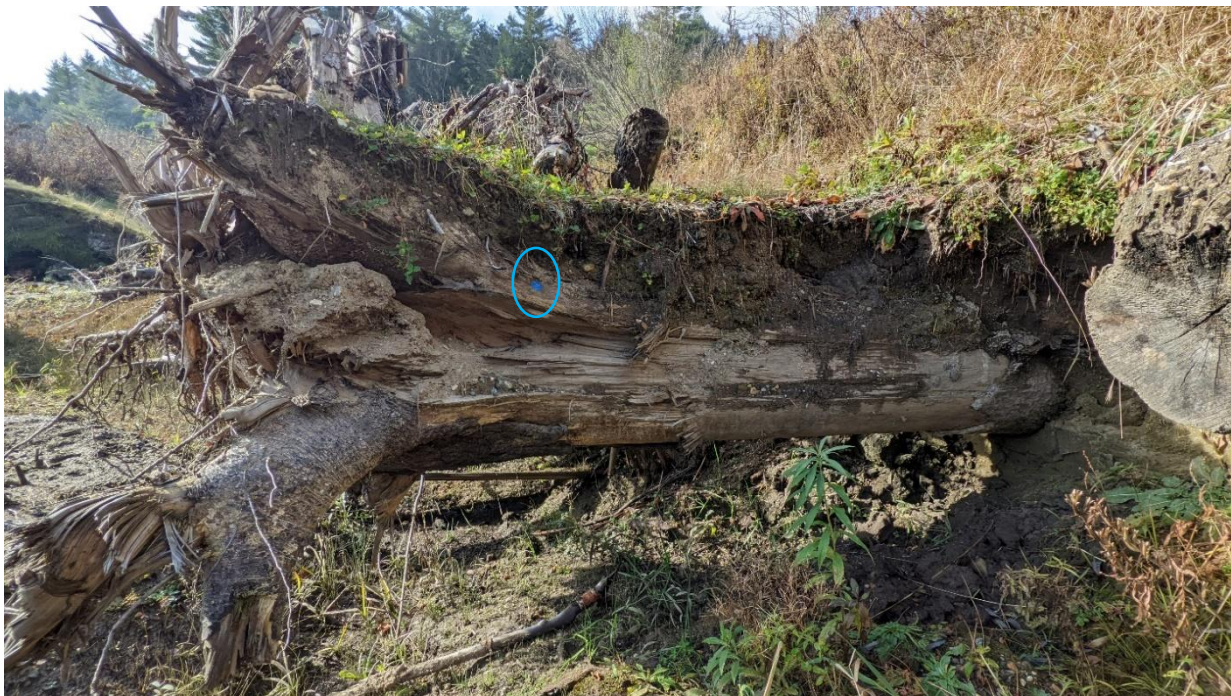
Figure 4. Image of an installed rootwad at WR2 with the blue metal tag highlighted with a blue circle.

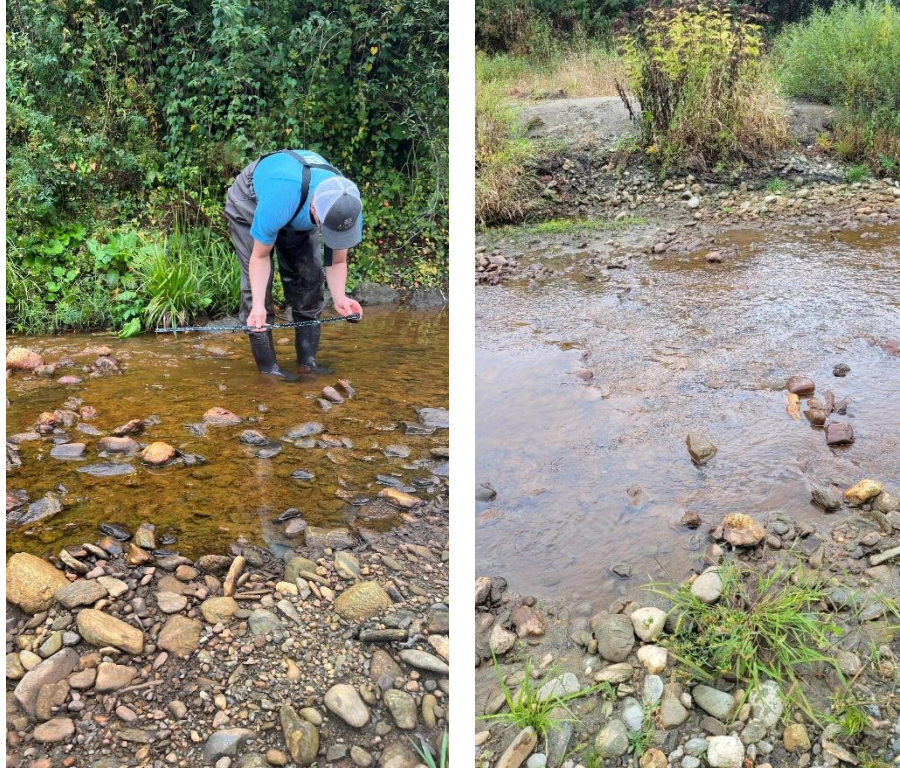
Figure 5. Streambed material analysis locations Site 101 (left) and Site 102 (right).

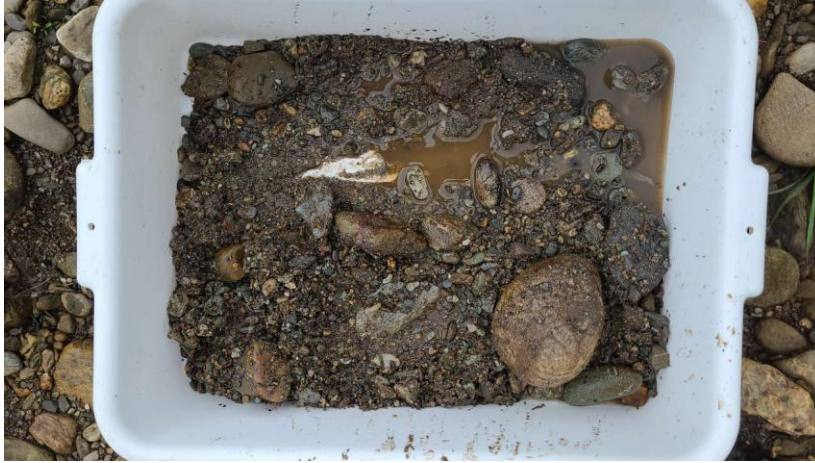
Figure 8. Sediment below surficial layer, Site 101.

Results of the visual and tactile assessment of sediment beneath the surficial layer are summarized in Table 2 and presented in photographs in Figure 8 and Figure 9.

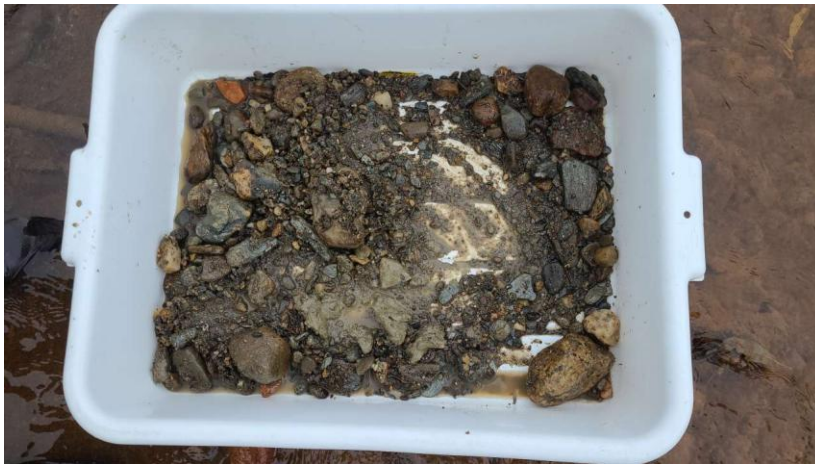
Figure 9. Sediment below surficial layer, Site 102.

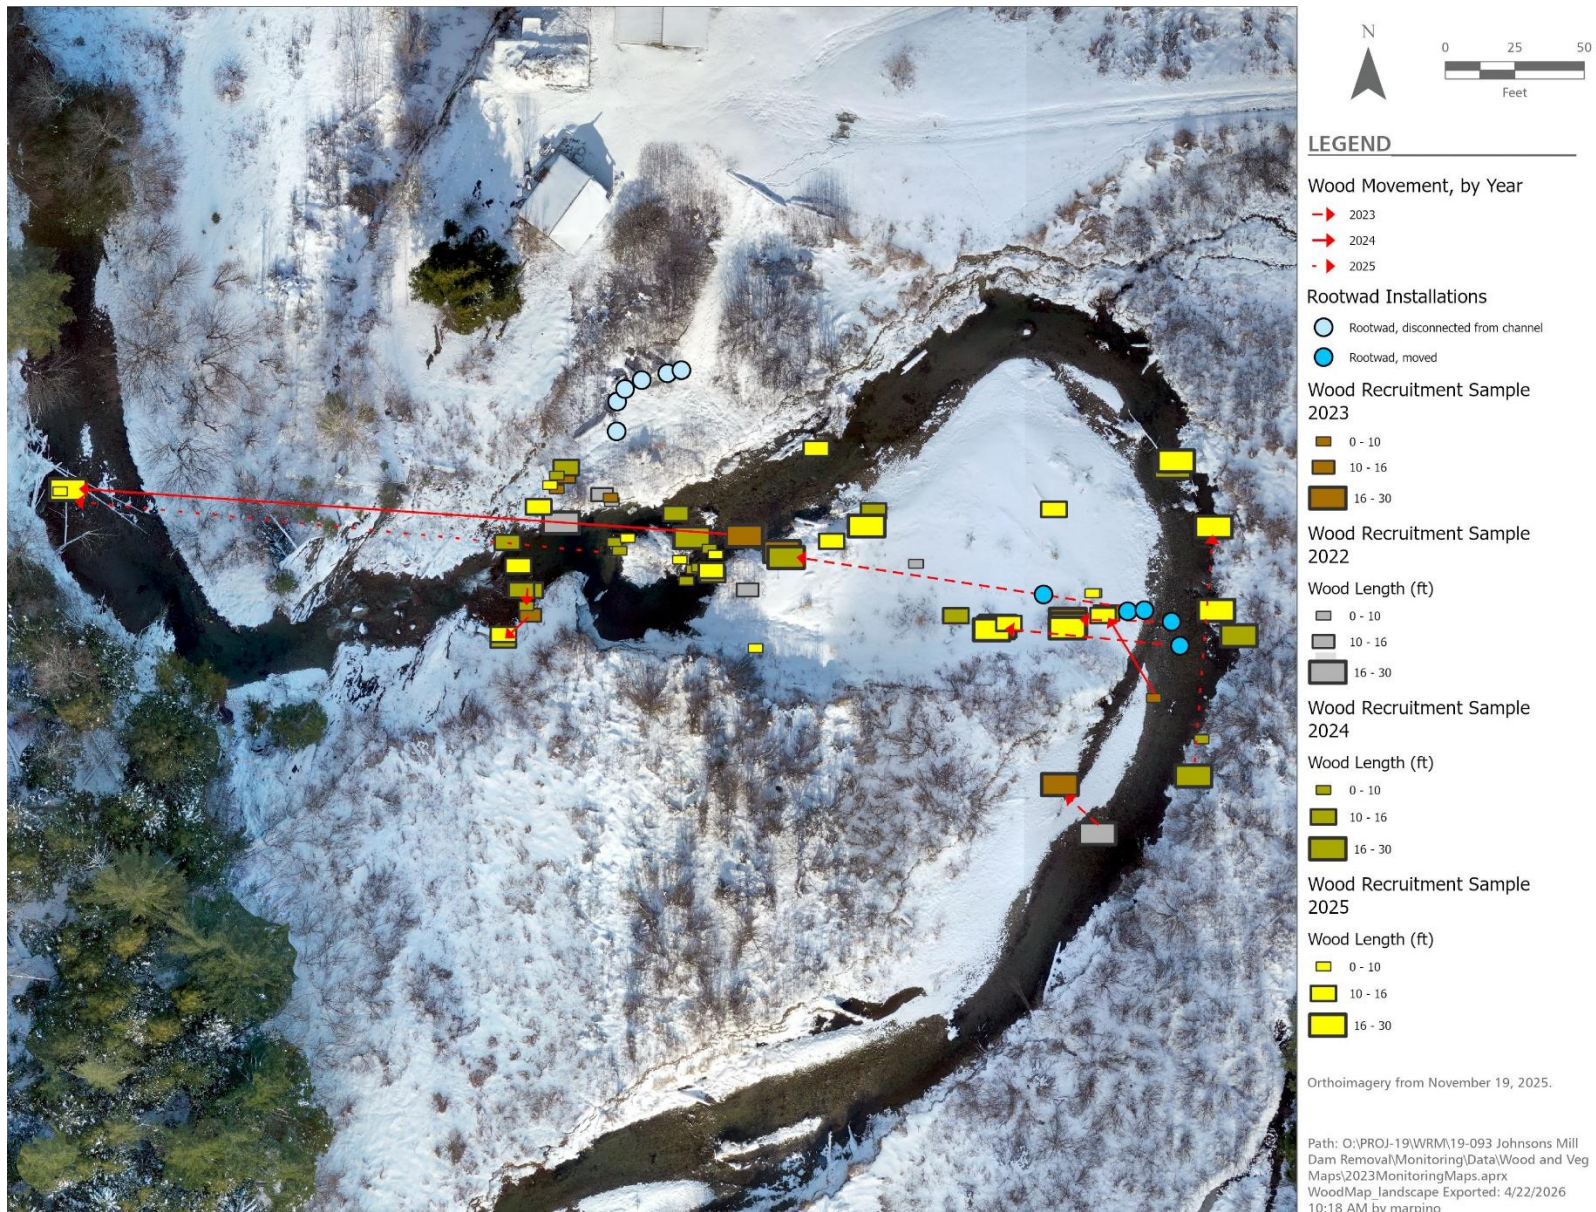
Evaluation of wood recruitment included assessing installed rootwads and naturally recruited woody debris within the channel. In 2023, Stone staff observed that all the rootwads from WR1 had been dislodged from the bank and only three of the five rootwads were found downstream within the monitoring reach, with the remaining two assumed to have been carried downstream beyond the monitoring reach. In 2025, There was little to no change at WR2 from Year 1 through Year 4 due to the disconnection of these rootwads from the main channel.

Figure 10. Annual woody debris and rootwad spatial and size distribution observations, with observed movement is shown with red arrows.

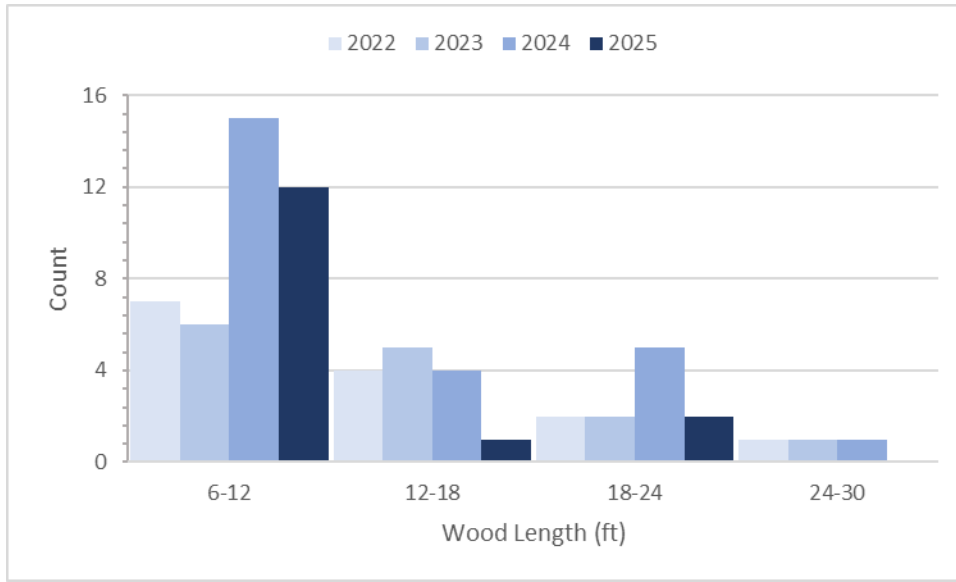
Table 4 presents the migration distances of tagged woody debris observed the monitoring period. Figure 11 through Figure 13 summarize the dimensions and general locations of the woody debris greater than 3 inches in diameter. The total volume of the recruited wood observed in 2025 equaled approximately 17 cubic yards (CY), including two rootwads that are now located in the channel. Woody debris was primarily recruited along the river left bank (looking downstream) or on the point bar located at the meander bend upstream of the former dam location. Much of the tagged woody debris pieces were timber logs that had previously been buried under the dam impoundment and may have been part of timber cribbing or other structures associated with the dam. These timber logs became exposed following dam removal and the subsequent channel adjustment.

Figure 11. Summary of wood length within the monitoring reach of the Bogue Branch.

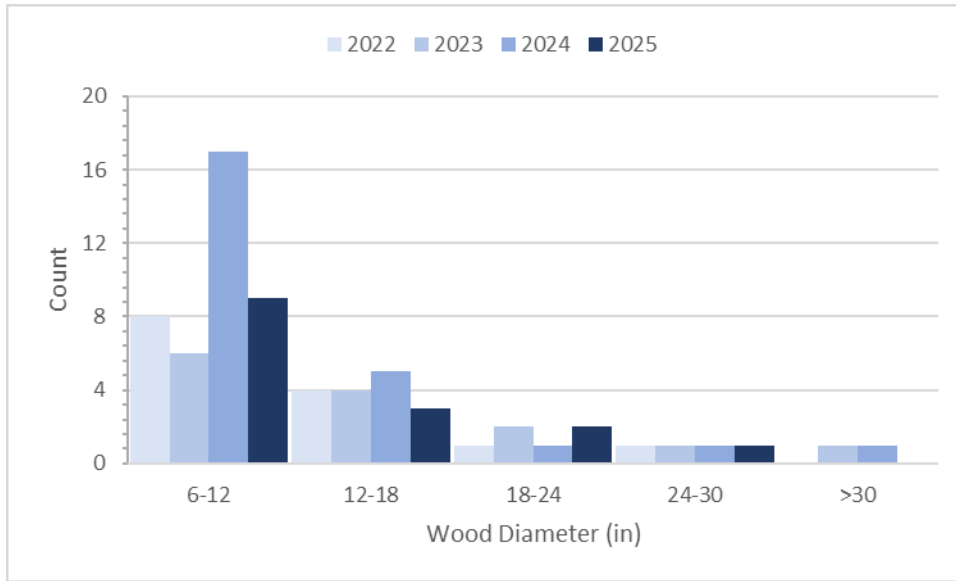
Figure 12. Summary of wood diameter within the monitoring reach of the Bogue Branch.

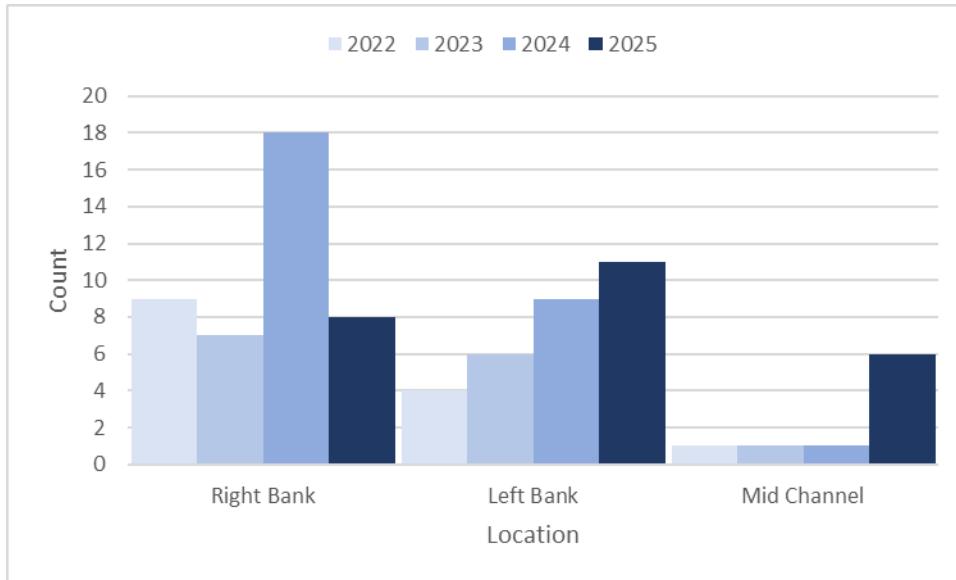
Figure 13. Summary of wood location within the monitoring reach of the Bogue Branch.

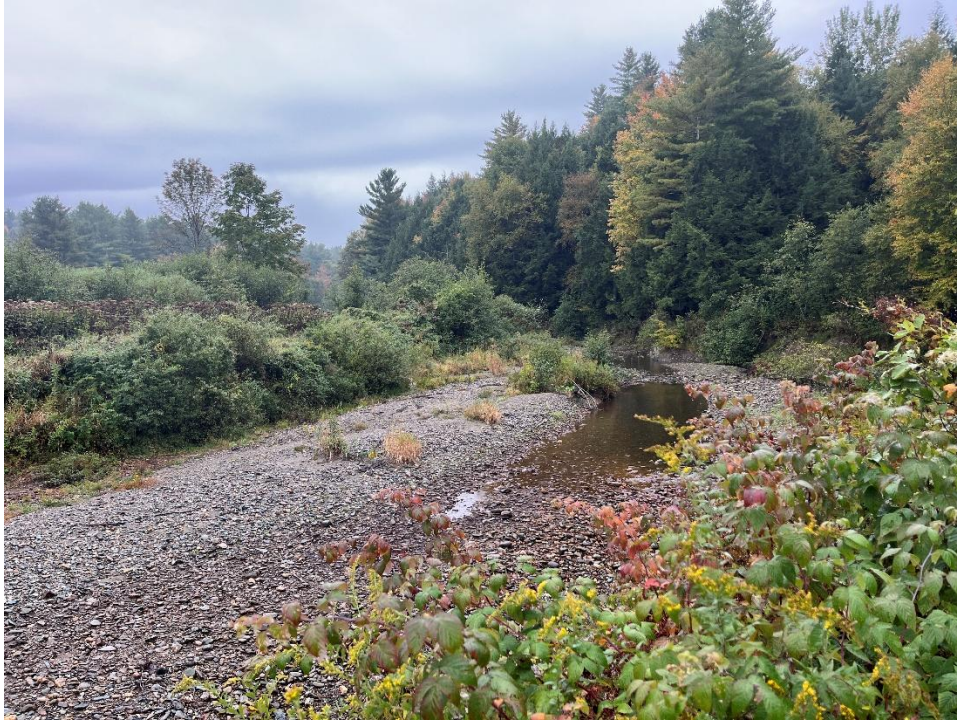
Figure 16. Looking upstream from Stand 8 in 2025.

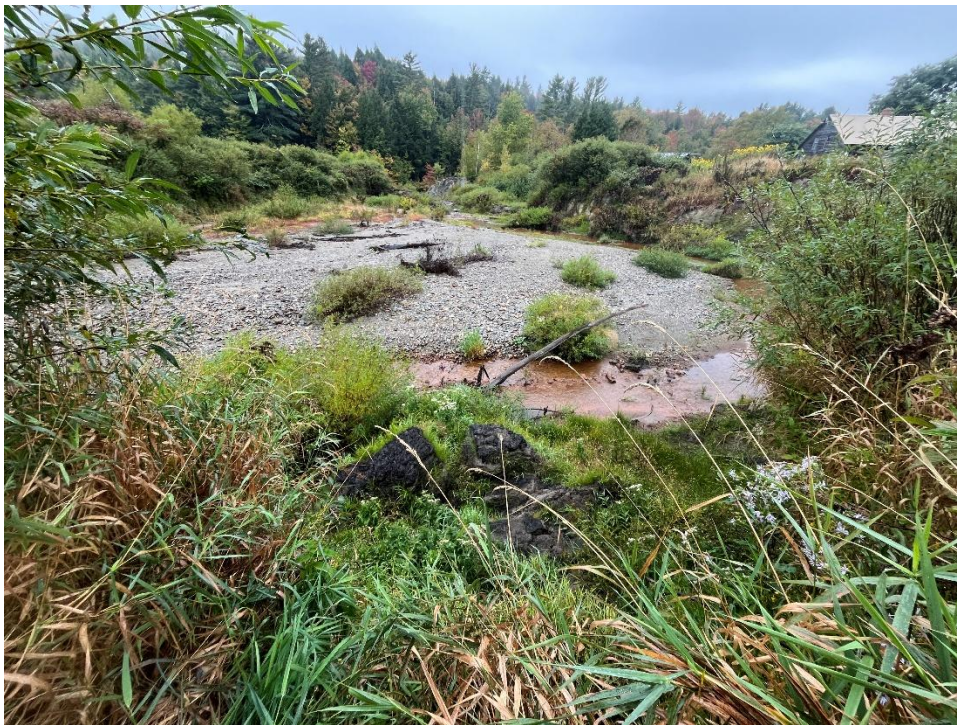
Figure 17. Photo taken from river right bank on meander bend migrating towards driveway looking at point bar with newly established vegetation and vegetated steep banks on river left.

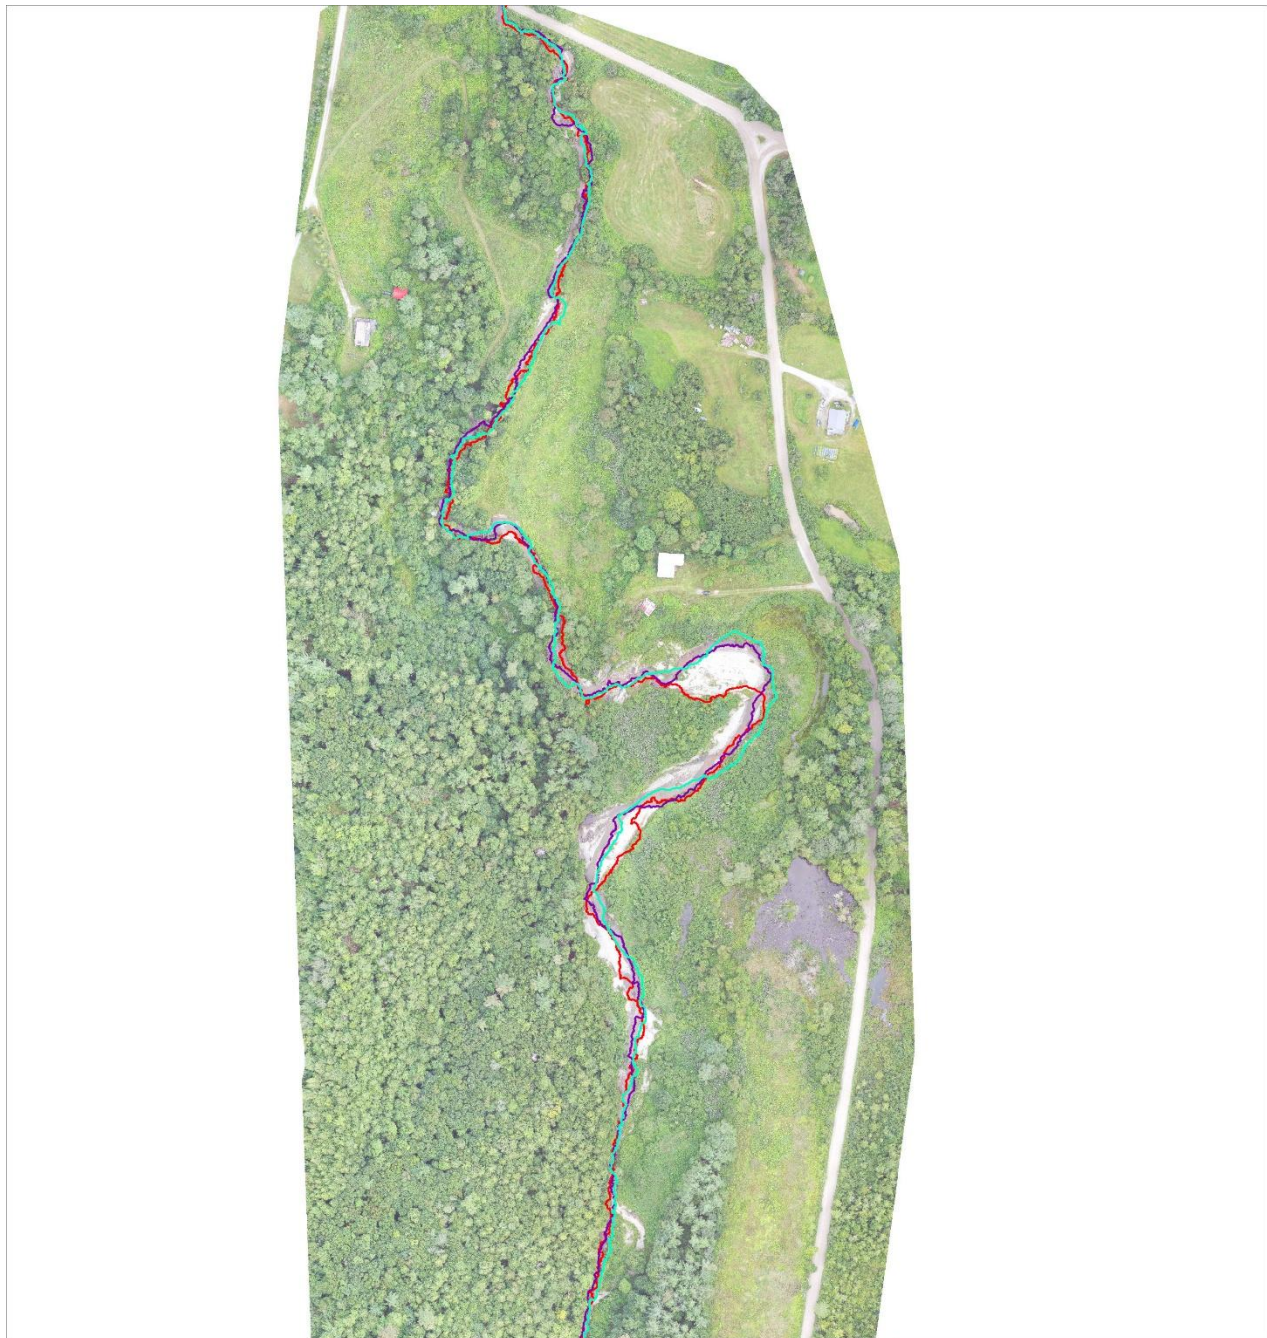
The DEMs generated from lidar data collected during monitoring years were also compared to assess lateral channel migration over time. These comparisons are shown in Figure 18 and depict the lateral migration of the channel centerline for 2023 through 2025.

Figure 18. Channel thalweg lateral migration over the course of monitoring Year 2 through Year 4 when topobathymetric lidar data were collected for the project AOI.
