ARCHAEOLOGICAL RESOURCES ASSESSMENT AND HISTORIC RESOURCE REVIEW, TROUT BROOK RESERVOIR DAM REMOVAL PROJECT, BERKSHIRE, FRANKLIN COUNTY, VERMONT

UVM Report No. 1639

October 21, 2024 Revised February 26, 2025 REDACTED

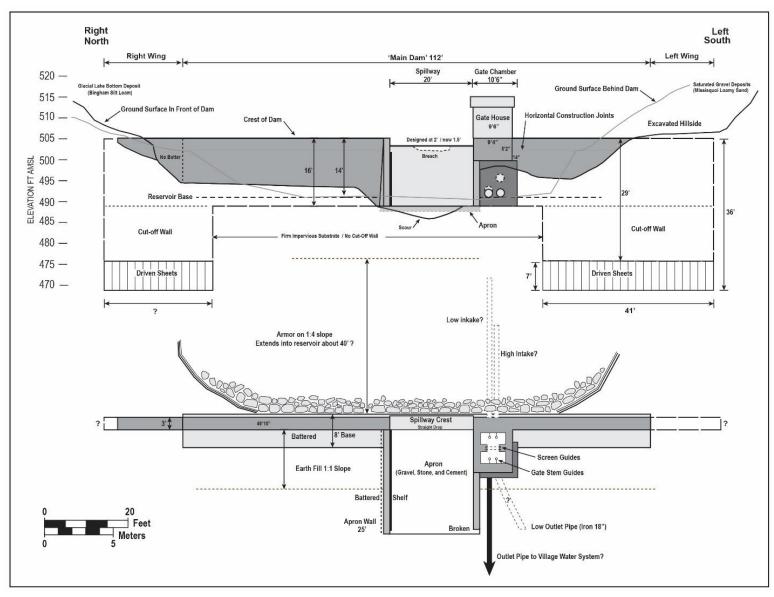
The geology of the site, specifically the unconsolidated sandy/gravelly deposits associated with the isolated kame and esker features at either the end of the structure resulted in the addition of two 'cut-off' walls²¹ to the design while the dam was being built to prevent the flow of water under or around the structure (see Figure 36) (Enosburg Falls 1925:26). According to Thorpe,

Figure 36. Elevation and plan of the Trout Brook Reservoir Dam, Bakersfield, Vermont.

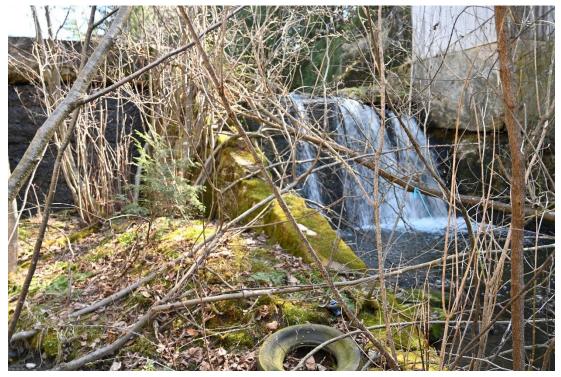
The Trout Brook Reservoir Dam, VT State ID #19.02, lies at latitude 44.9373114, longitude -72.78175971. The dam is a low, reinforced concrete masonry, straight, gravity-type dam on an earthen foundation and has earthen embankments on both its upstream and downstream sides (Figures 36 and 37). The dam is assessed as in poor condition with significant cracks through its horizontal construction joints and seepage occurring under the structure (SLR 2023:1). The main (or central) section of the dam is 112 ft long and is about 16 ft high (Figure 38) (Enosburg Falls 1925:26; SLR 2023:3-4). The crest sits about 14 ft above the bottom of the reservoir (Enosburg Falls 1925:26; SLR 2023:3-4). The dam has a crest thickness of 3 ft and a base thickness of 8 ft (Figure 39) (Enosburg Falls 1925:26). However, the crest length given for the main dam does not include the "cut off walls" (wings) that "extend from the main section into the banks at both ends" (Figure 40) (Enosburg Falls 1925:26). Presently, the full traceable crest of the structure is about 128 ft (see Figure 12).

Figure 37. View of the Trout Reservoir Dam, looking northeast.

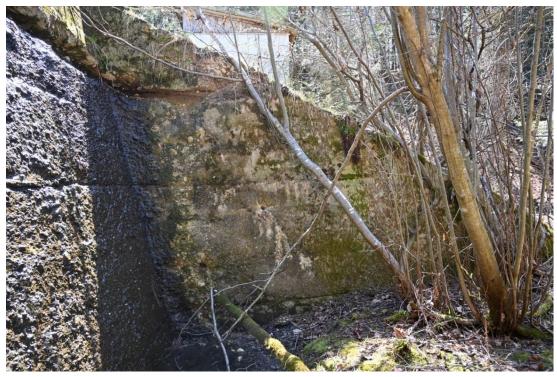
side of the structure are the apron (or lead) walls (Figures 43 and 44). These board formed concrete walls are 18 in thick and extend downstream about 25-26 ft. They guided the water away from the dam and in this case, protected the downstream earthen fill along the front of the dam. The right apron wall has a slight batter outward and a narrow 6 in 'shelf' running parallel to and 30.5 in below its top. The purpose of this last feature is not clear, but it could be a reinforcement. Directly below the spillway's straight drop was the dam's apron.²⁴ According to Thorpe, the apron's deck was composed of "gravel, over which stone paving, bedded in cement mortar, [was] laid" (Enosburg Falls 1925:26). Although this could not be directly observed during the field visit due to the water levels, this apron may be significantly damaged and/or largely lost. The SLR 2023 report indicates that there is a "large scour hole below the spillway undermining the dam" as well as a significant amount of displaced concrete and rip rap that has been distributed up to 40 ft downstream from the dam (SLR 2023:3-4). The apron would have dissipated the force and velocity of the water coming off the spillway and prevented scour at the toe of the dam. The main or central portion of this dam is battered outward slightly on its downstream side (Figure 45) (SLR 2023:3-4). According to Thorpe, "the downstream face" of the dam was also "protected by an earth embankment" when the structure was built (Enosburg Falls 1925:26). However, not much of this feature remains in place. It appears that water has been flowing over the non-spillway section of the dam and eroding this material away for some time.

Figure 43. View of the outside surface of the right apron wall, looking east.

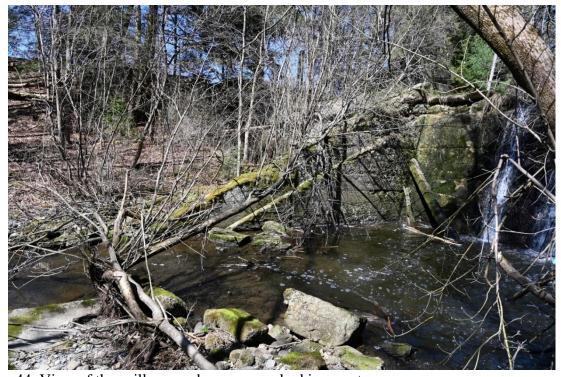
Figure 44. View of the spillway and apron area, looking west.

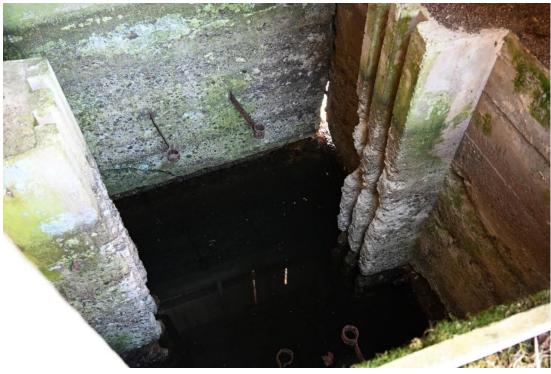
To the left of the spillway, on the downstream side of the dam, there is a gate chamber (or control chamber), which was built as "an integral part of the dam" (e.g., one part of the chamber wall is also part of the left apron wall and another part of the chamber wall is also part of the main dam 25) (Figures 46 – 49) (Enosburg Falls 1925:26; SLR 2023:3-4). The exterior of the chamber measures 9.33 by 10.25 ft and it "extends from the bottom of the reservoir to the top of the dam" (Enosburg Falls 1925:26). The lower part of the chamber is reinforced by an additional 13-14 in of concrete on two sides starting at 4 ft 6 in down from the crest next to the dam face and angling down to 5 ft 2 in below the dam crest on its downstream face. The interior space of the chamber measures 7 ft 4 in by 6 ft and has walls about 26 in thick. This space likely included both the intake and outlet gates for the dam. Four ferrous gate thread guides are still in position protruding from the chamber's walls, two on the upstream wall and two on the downstream wall, but the floor of the gate house and the hoist mechanisms are no longer present. It is possible that the gate leaf(s) and guides, or, possibly in this case, gate valves could still be present under the water (Figure 50). According to Thorpe, "the gates are so located that the water can be drawn from the bottom of the reservoir or from a point 5 ft above the bottom" (Enosburg Falls 1925:26). Built into the foundation of the control chamber were formed concrete guides designed to retain frames equipped with ¼ in copper mesh screens (Enosburg Falls 1925:26). These screens were placed to "prevent all floating matter as well as fish from entering the piping system" (Enosburg Falls 1925:26). All the water in the system had to pass these screens (Enosburg Falls 1925:26). The screens were "removable and can easily be taken out and cleaned when necessary" (Enosburg Falls 1925:26). The formed gate guides were 2.5 in wide.

Figure 50. View of the interior of the gate chamber; note the concrete formed guides for the copper screens and the metal gate thread guides.

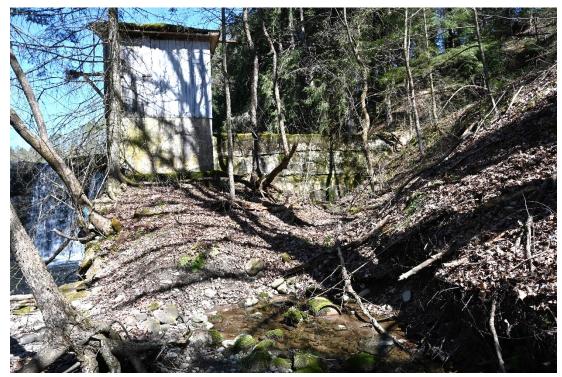
A wooden gate house sits on top of the gate chamber. The structure has vertical board siding and a shed roof. On its upstream side, it measures 116 in from the top of the dam to the bottom its roof, on the downstream side is measures 93 in to the base of the roof. The structure has one 30 in wide door opening centered on in its upstream (north) side, two rectangular openings at ground level to the left of the door, one rectangular opening at ground level to the right of the door, and a small window type opening under the roof line on the east wall. A plain wooden bracket is attached to the rear (south) wall of the gate house just above the concrete chamber (Figures 52 and 53).

Thorpe noted that, "a blow-off pipe is provided and discharges into the brook at a point a short distance below the dam" (Enosburg Falls 1925:26). The end of an 18 in diameter iron pipe was observed partially buried in the streambed about 18.5 ft south of and about 5 ft below the visible concrete portion of the control chamber, which could be the 'blow-off pipe' (Figure 54; see Figure 52).

Figure 52. View of the gate house and control chamber on the left side of the spillway, looking west, note bracket on back of structure and pipe to left of milk can.

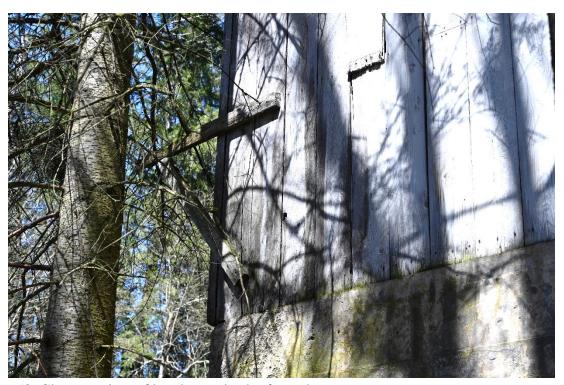
Figure 53. Close up view of bracket on back of gate house structure.

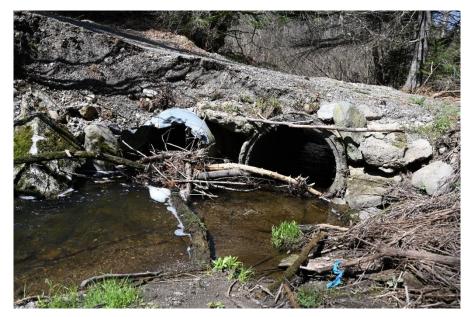
The culvert that carries Trout Brook under the access road to the farm field, well houses and dam, consists of two side-by-side pipes (Figures 68 and 69; see Figures 15 - 17). The large pipe is a 30-inch diameter concrete pipe, and the smaller pipe is a 24-inch diameter corrugated metal pipe. They are surrounded by road fill consisting of sediment, gravel, cobbles and rock and have no associated features such as head walls or wing walls. The culvert is not recommended as eligible for listing on the NR due to a lack of distinctive characteristics of type, period or method of construction.

Figure 68. View southwest of the inlet side of the culvert that carries Trout Brook under the west access road.

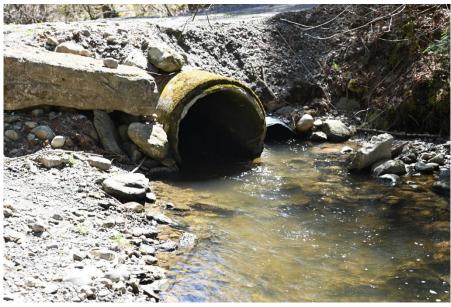
Figure 69. View southeast of the outlet side of the culvert that carries Trout Brook under the west access road.
